INTERVENTION

—日生劇場増築計画—

Hiroshi OTA

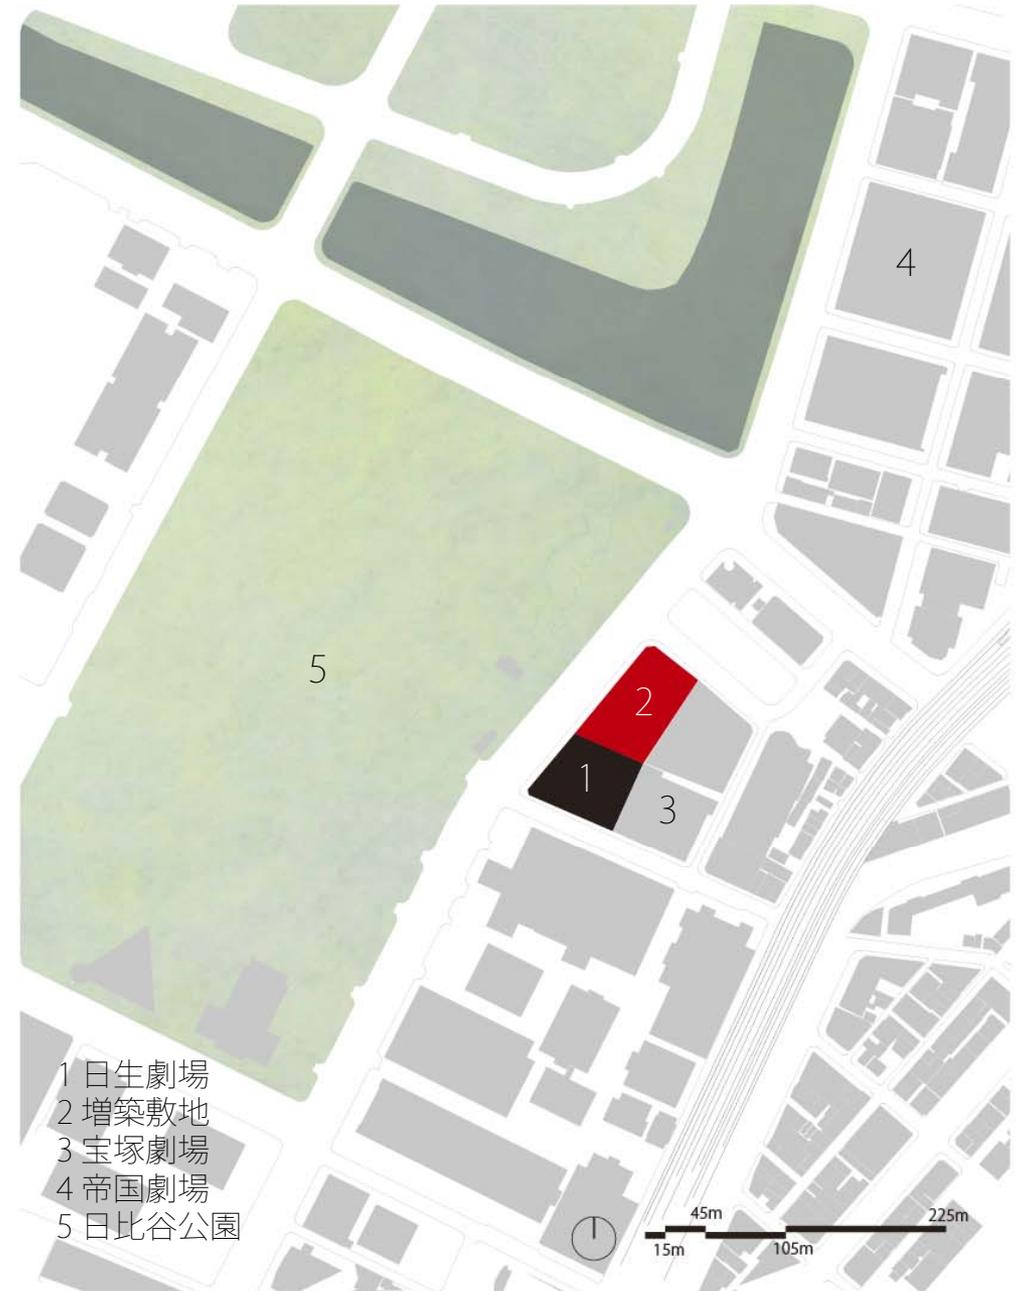
Whole Diagram

existing

pulling out
offices

void

intervention

annex

1963年竣工の日生劇場

機能不全に陥ったオ
フィス部分を減築

劇場の横に
ボイドが発生

異質な建築の
介入

外に溢れる介入
物が白く透明な
箱の中で佇む

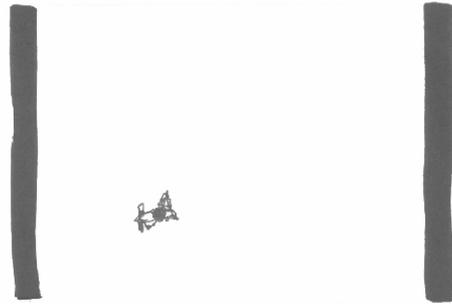
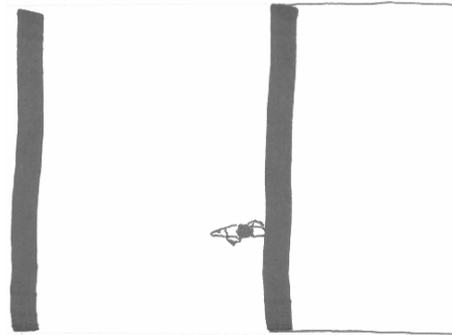
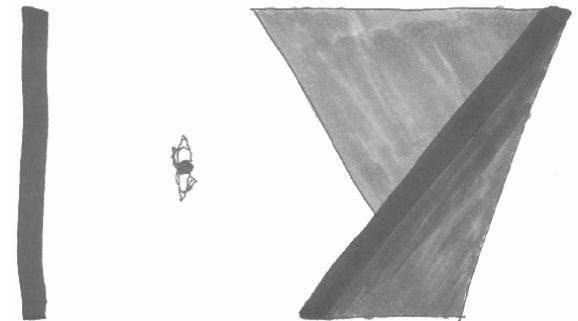
plan

Process 1 form

垂直

斜置

斜置+折れ

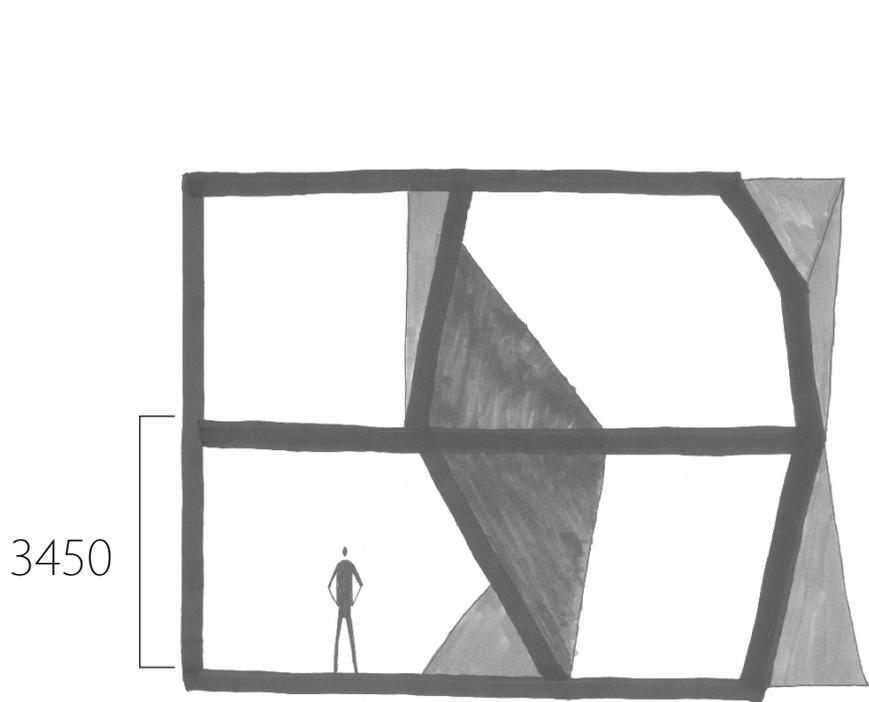
既存オフィスの階高

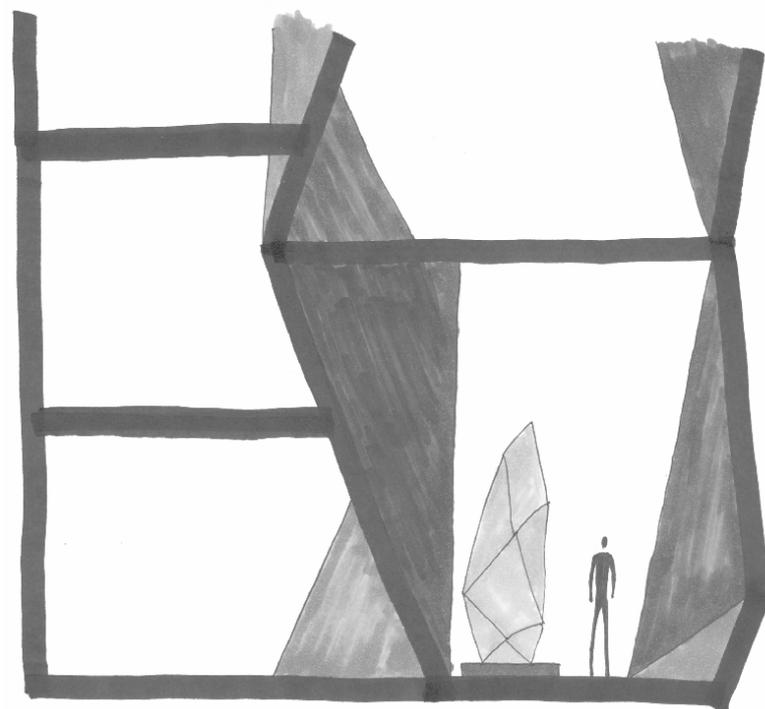
文化施設への階高の適応

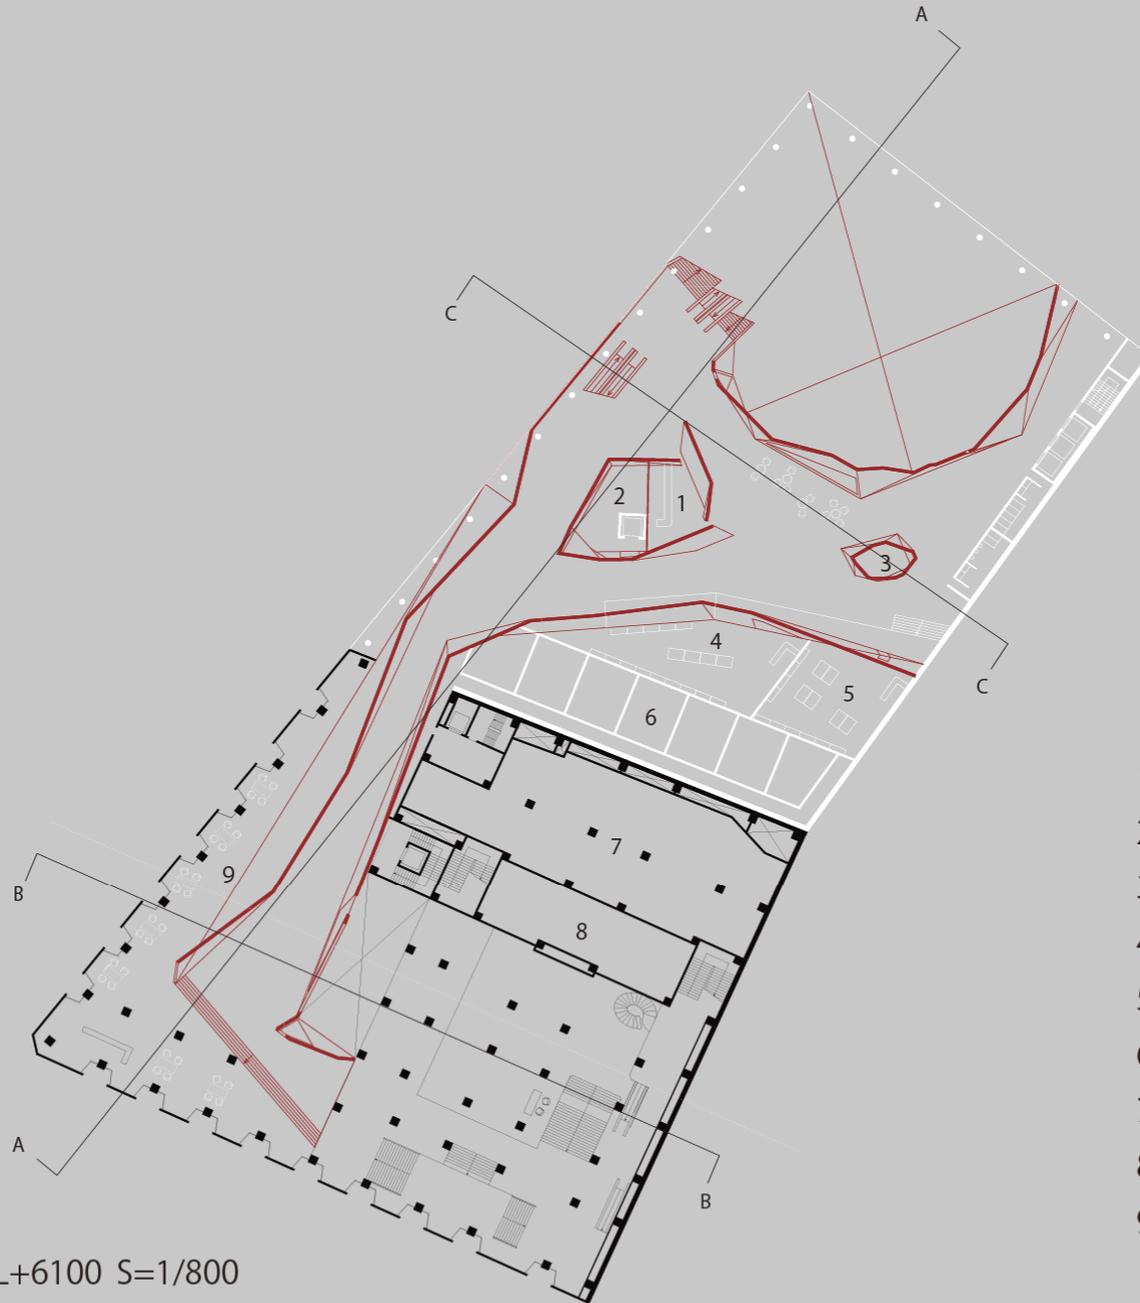
1st floor GL+2000 S=1/800

- 1. event hall
- 2. servant space 1
- 3. servant space 2
- 4. closed shelves
- 5. office 1
- 6. office 2
- 7. shop
- 8. abyss

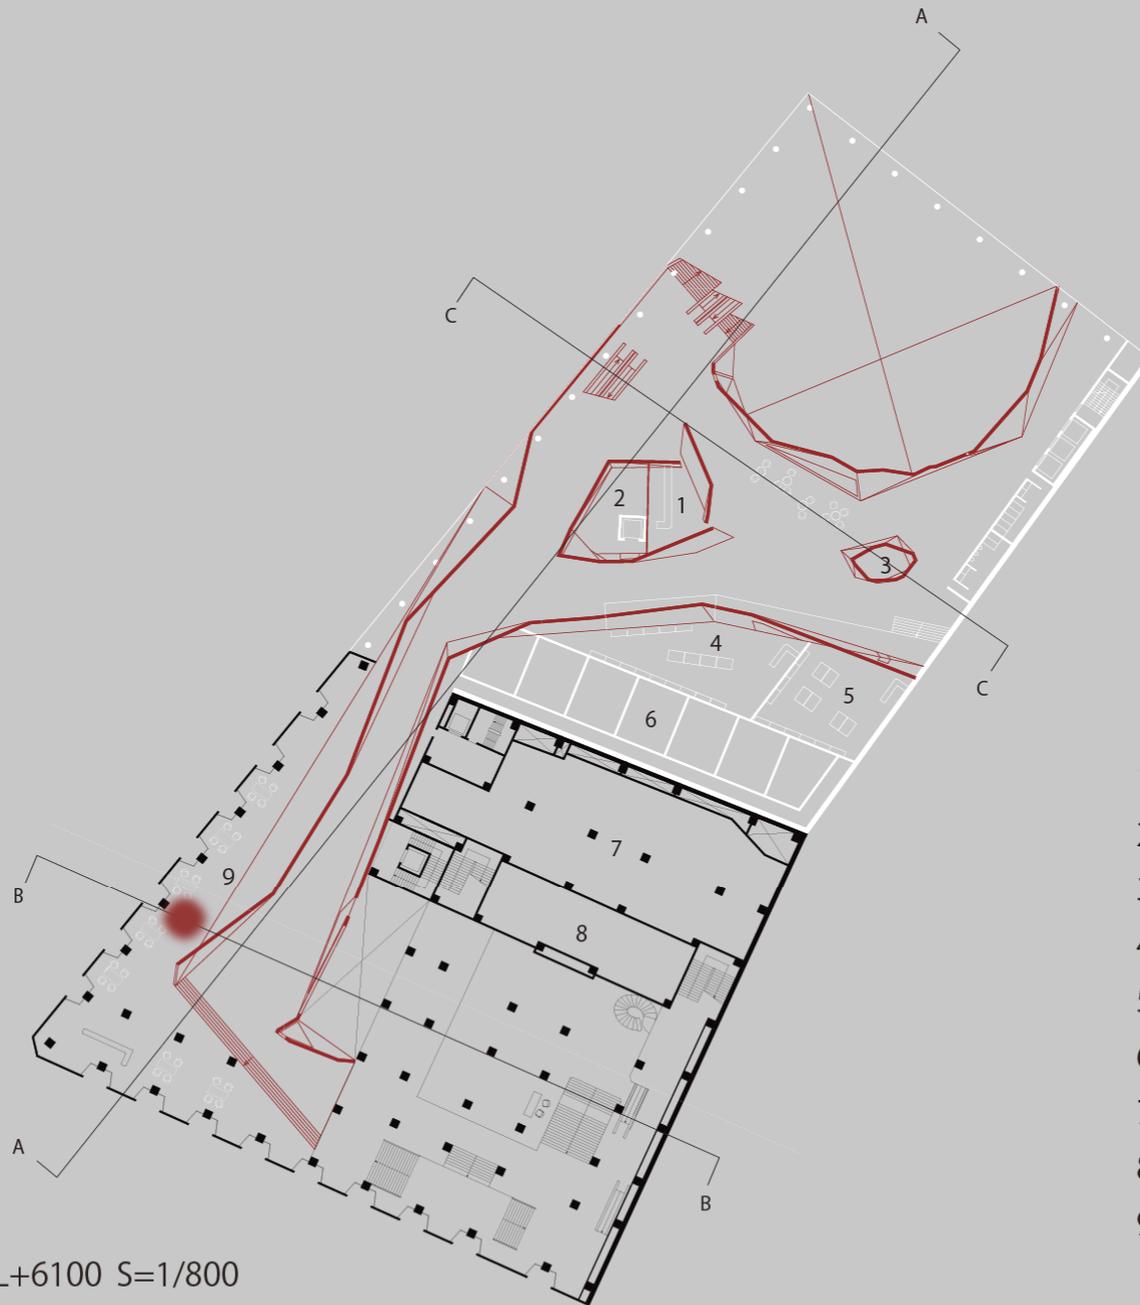
2nd floor GL+6100 S=1/800

- 1. cafe
- 2. servant space 1
- 3. servant space 2
- 4. shop 1
- 5. shop 2
- 6. dressing room
- 7. stage
- 8. orchestra pit
- 9. cafe & bar

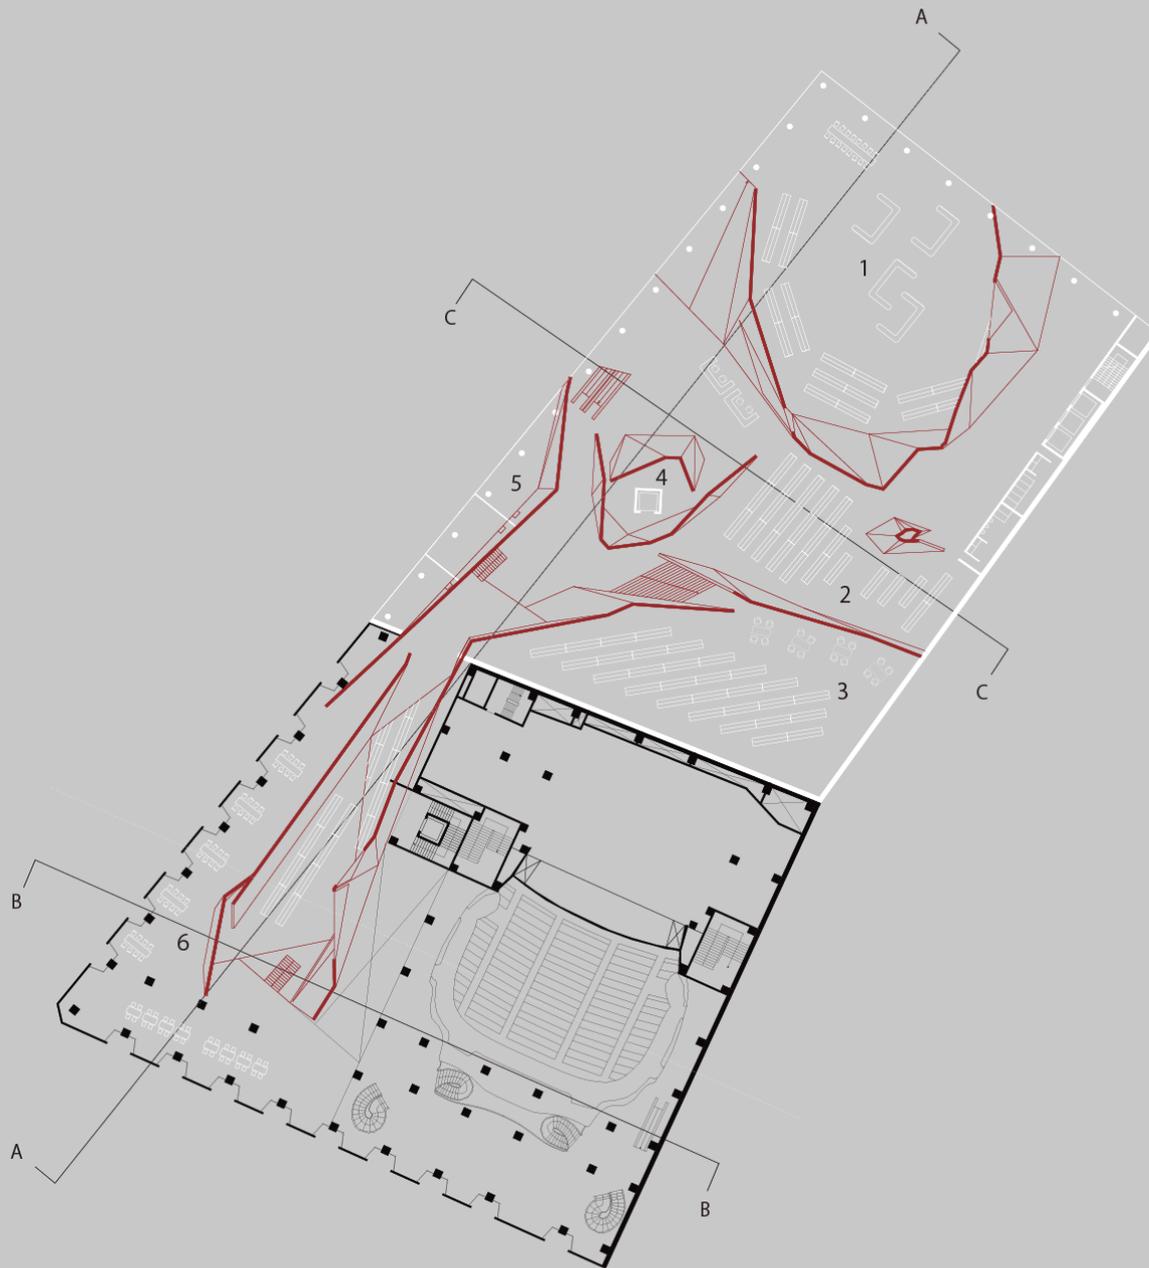
3rd floor GL+9100 S=1/800

- 1. library 1
- 2. library 2
- 3. library 3
- 4. servant space
- 5. reading room 1
- 6. reading room 2

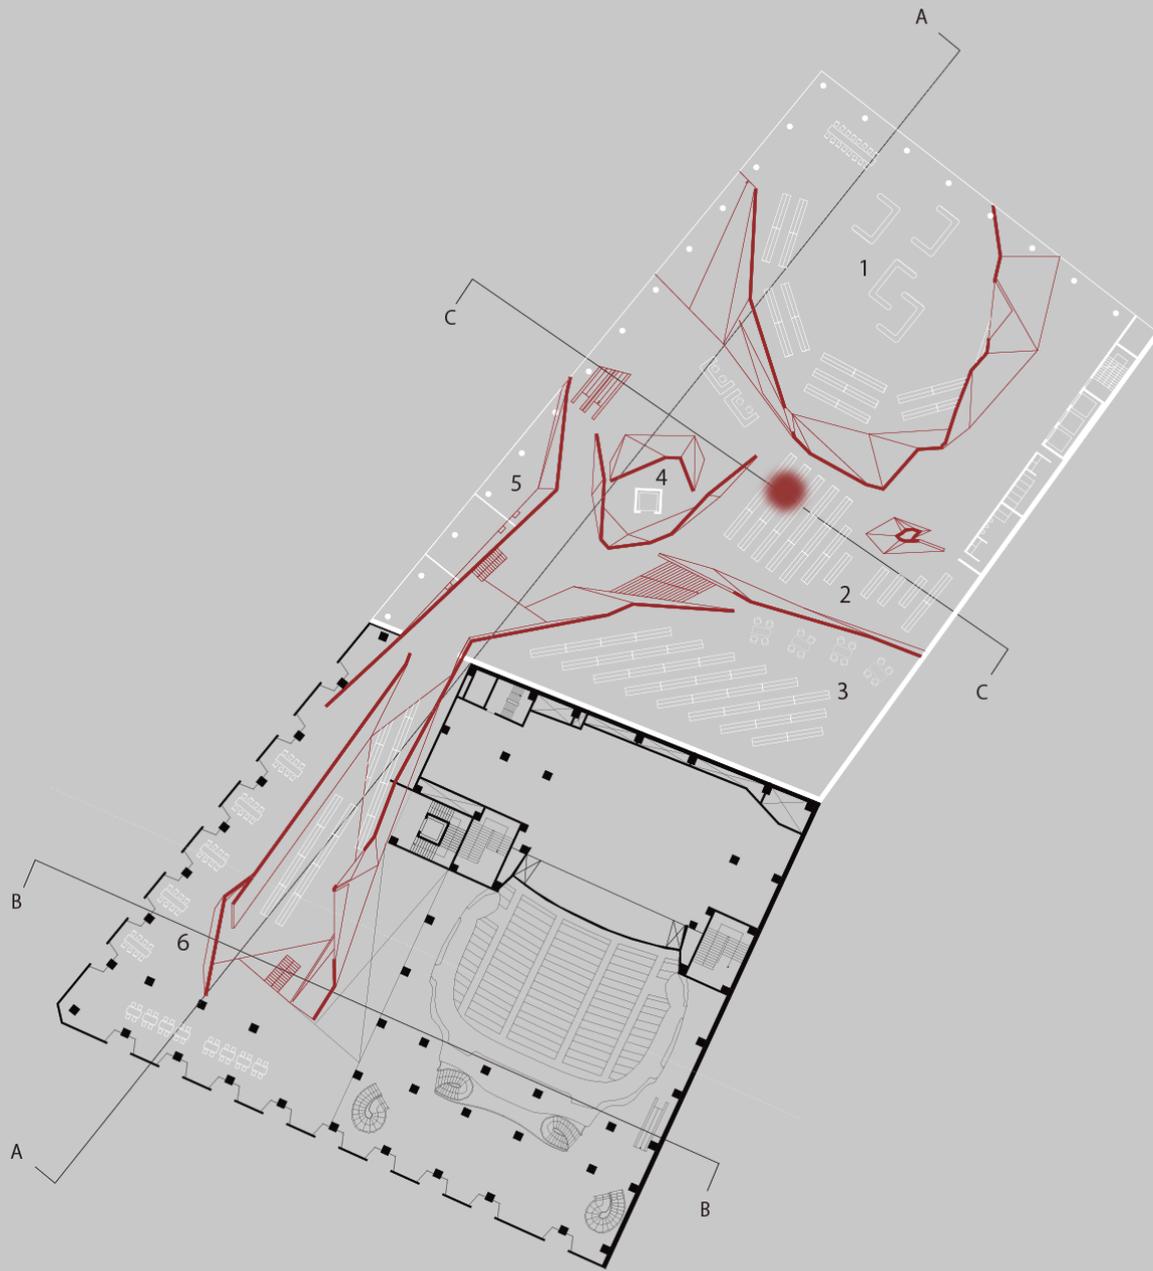
3rd floor GL+9100 S=1/800

- 1. library 1
- 2. library 2
- 3. library 3
- 4. servant space
- 5. reading room 1
- 6. reading room 2

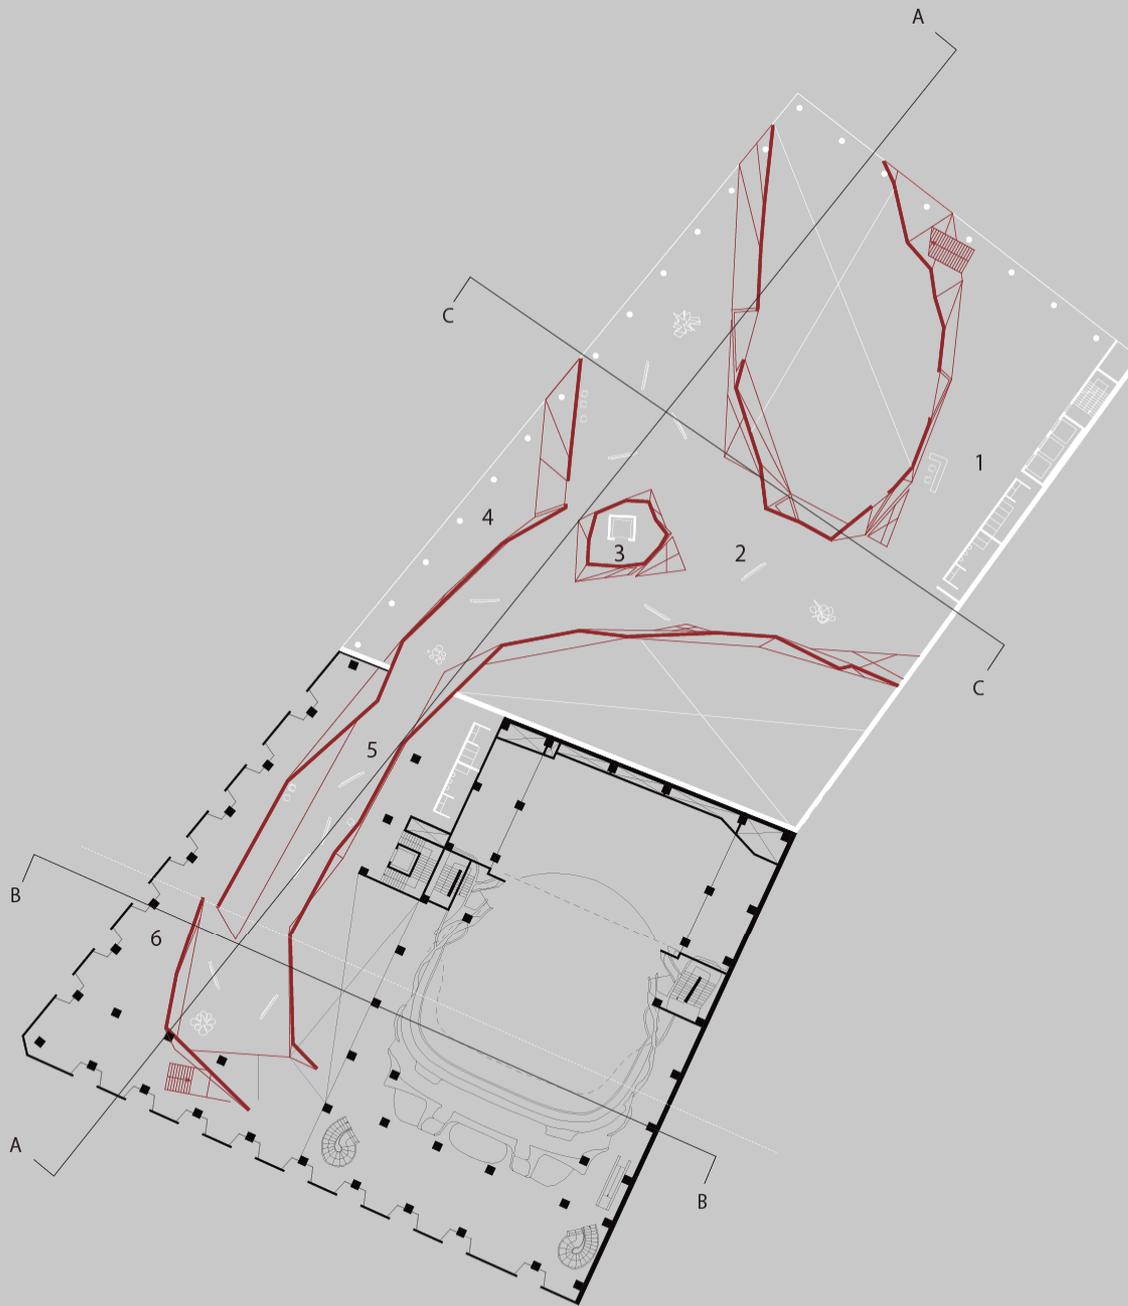
4th floor GL+15250 S=1/800

1. museum entrance
2. exhibition hall 1
3. servant space
4. exhibition hall 2
5. exhibition hall 3
6. exhibition hall 4

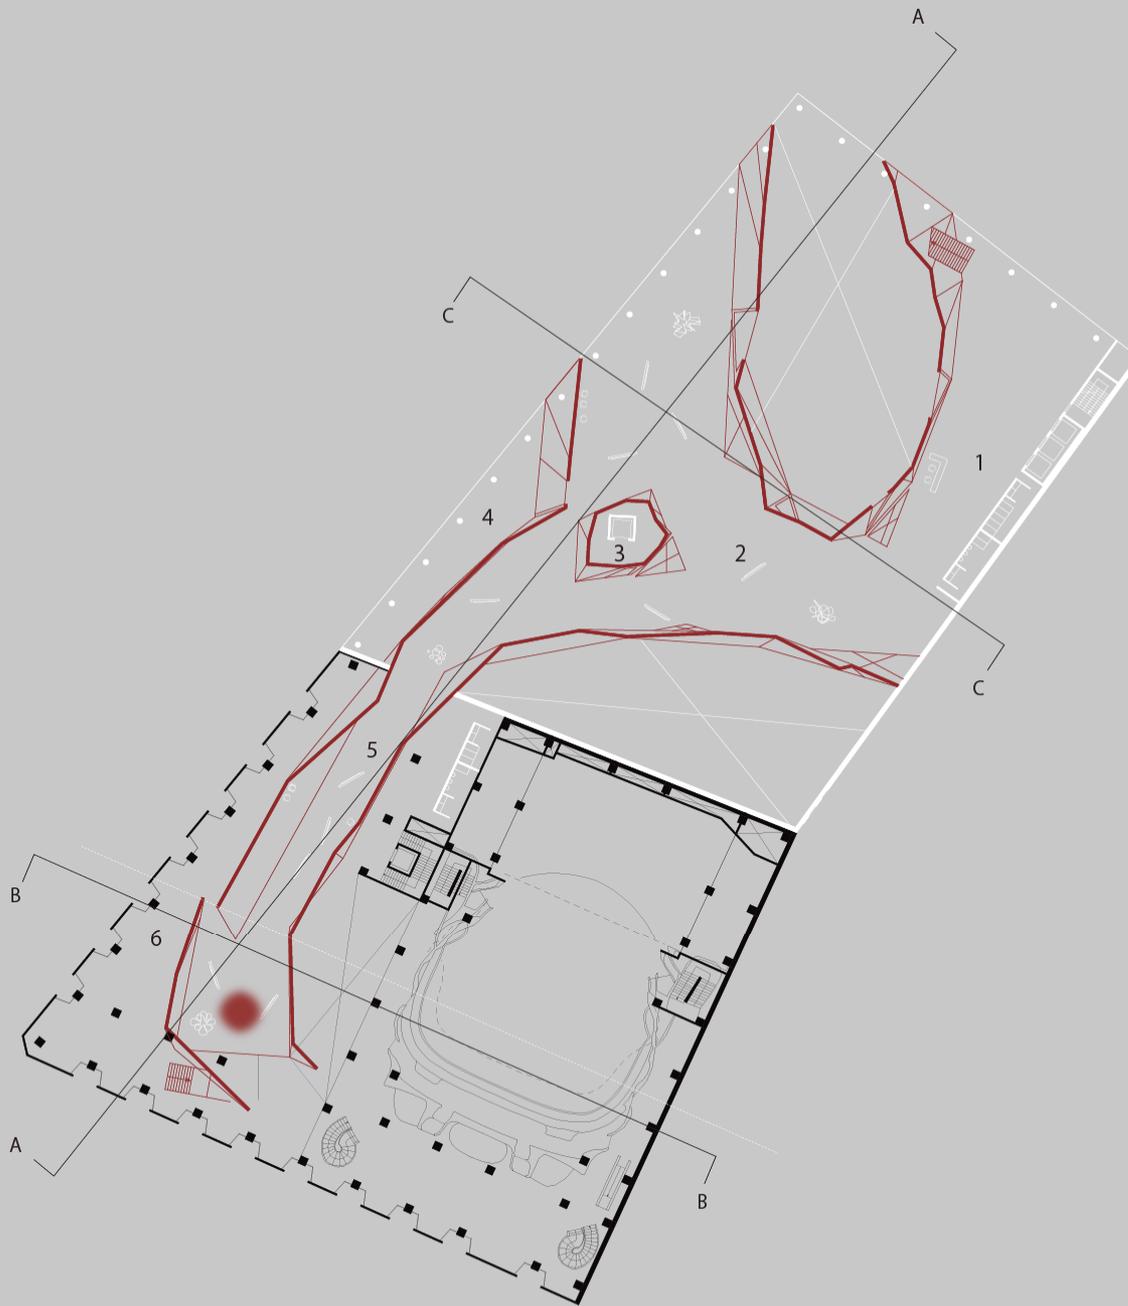
4th floor GL+15250 S=1/800

1. museum entrance
2. exhibition hall 1
3. servant space
4. exhibition hall 2
5. exhibition hall 3
6. exhibition hall 4

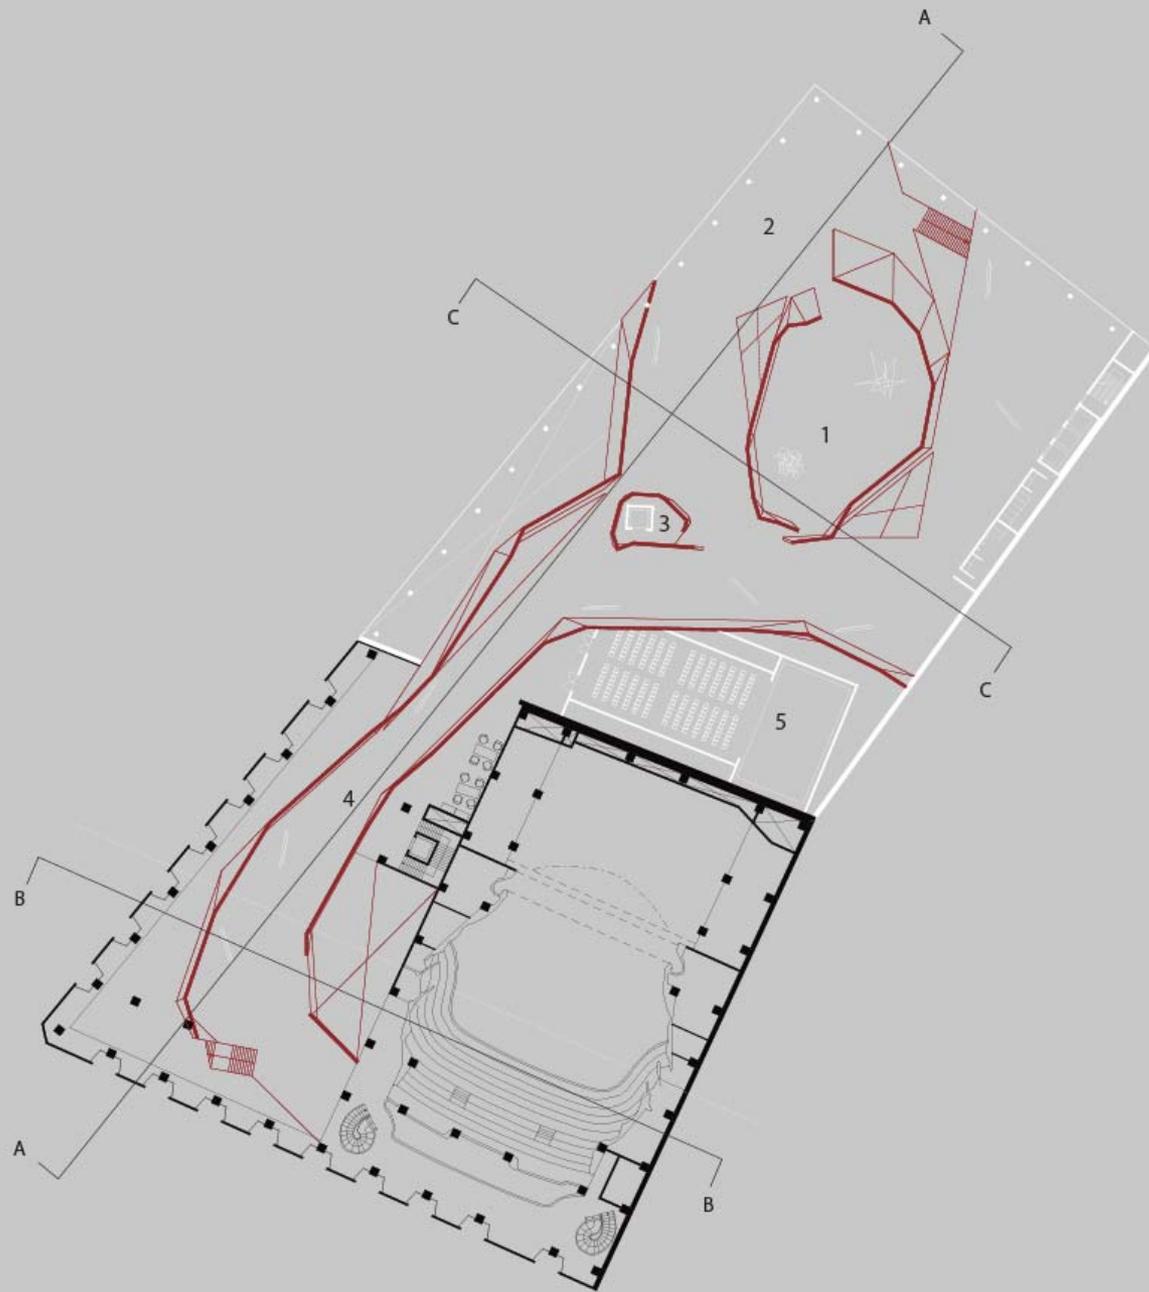
5th floor GL+18700 S=1/800

1. exhibition hall 1
2. exhibition hall 2
3. servant space
4. exhibition hall 3
5. small theater

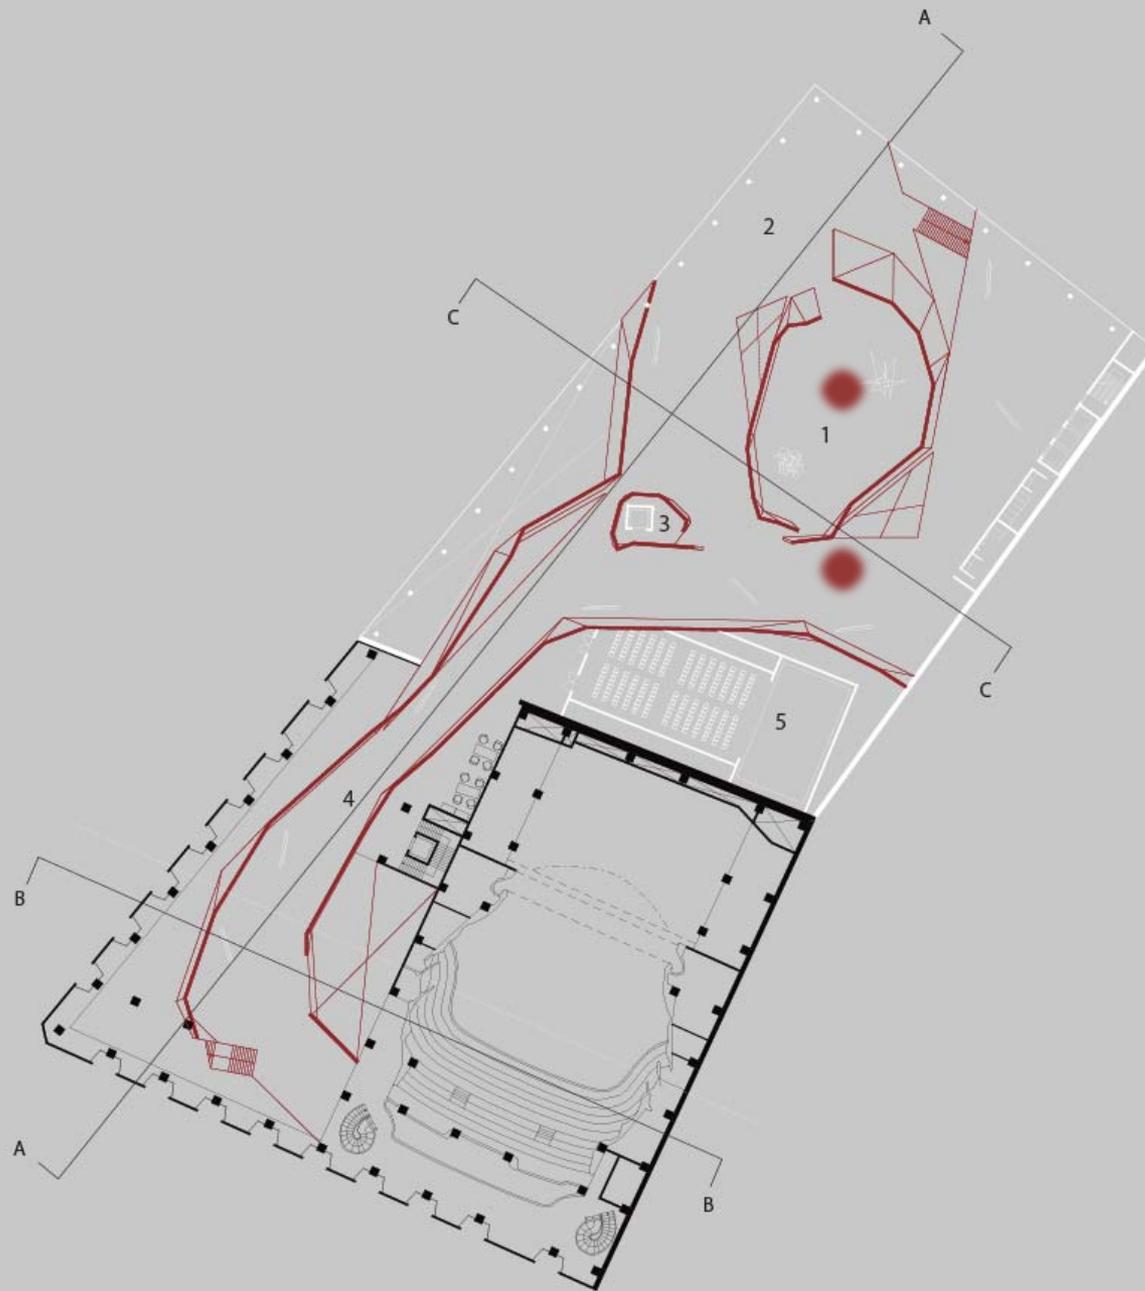
5th floor GL+18700 S=1/800

1. exhibition hall 1
2. exhibition hall 2
3. servant space
4. exhibition hall 3
5. small theater

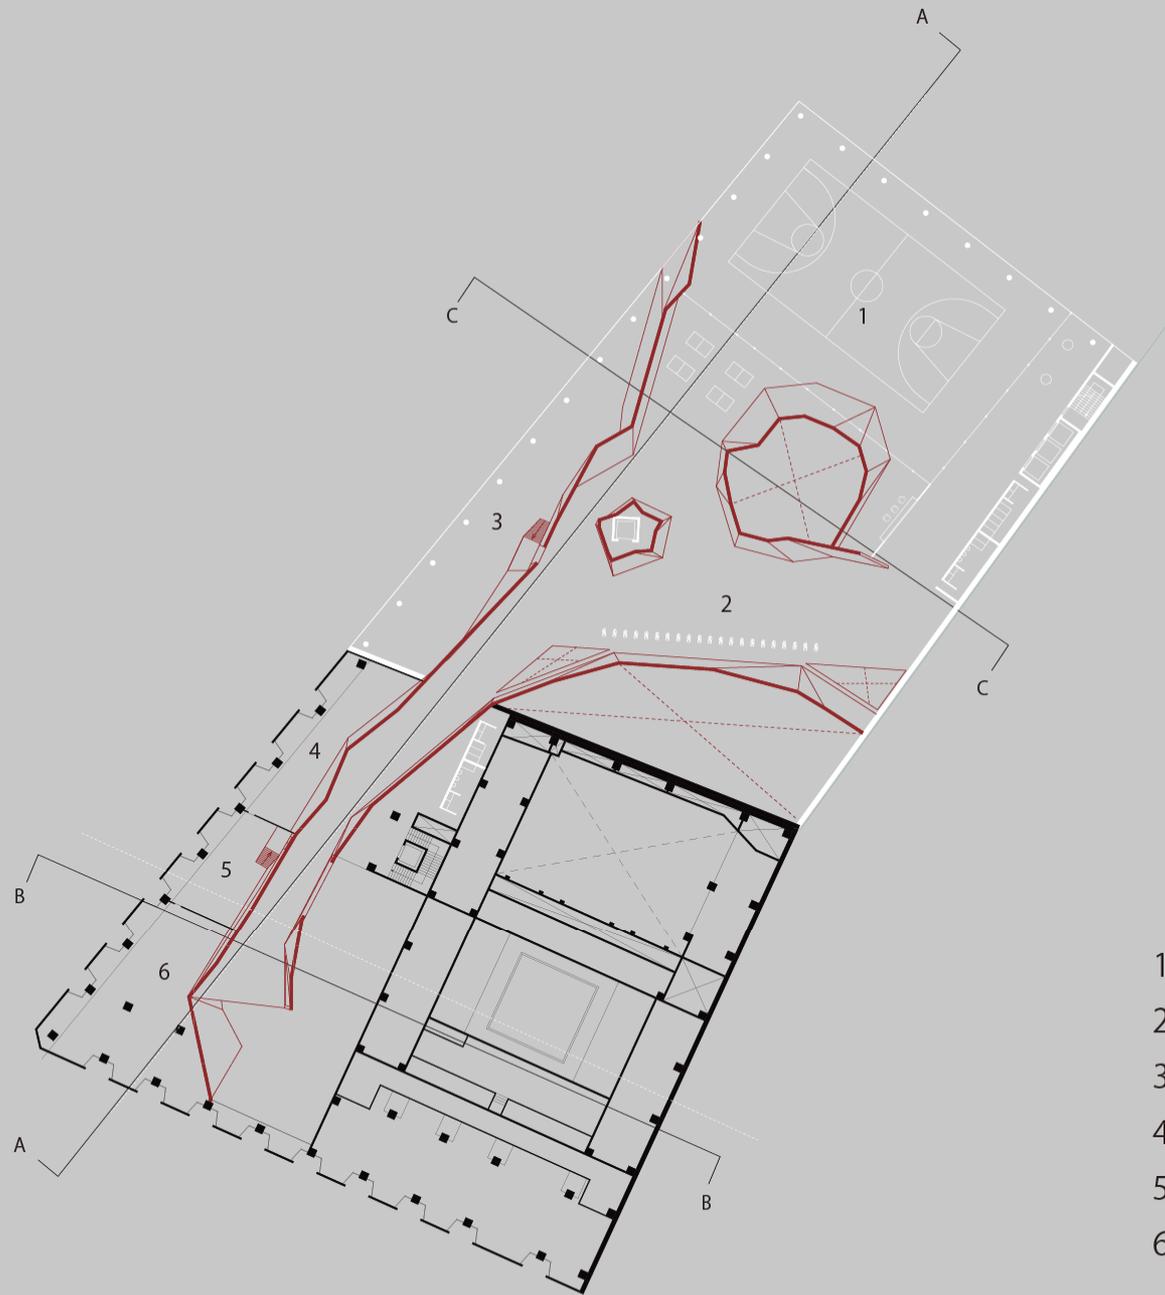
6th floor GL+24500 S=1/800

- 1. gymnasium
- 2. fitness club
- 3. rock climbing
- 4. dressing room 1
- 5. break room
- 6. dressing room 2

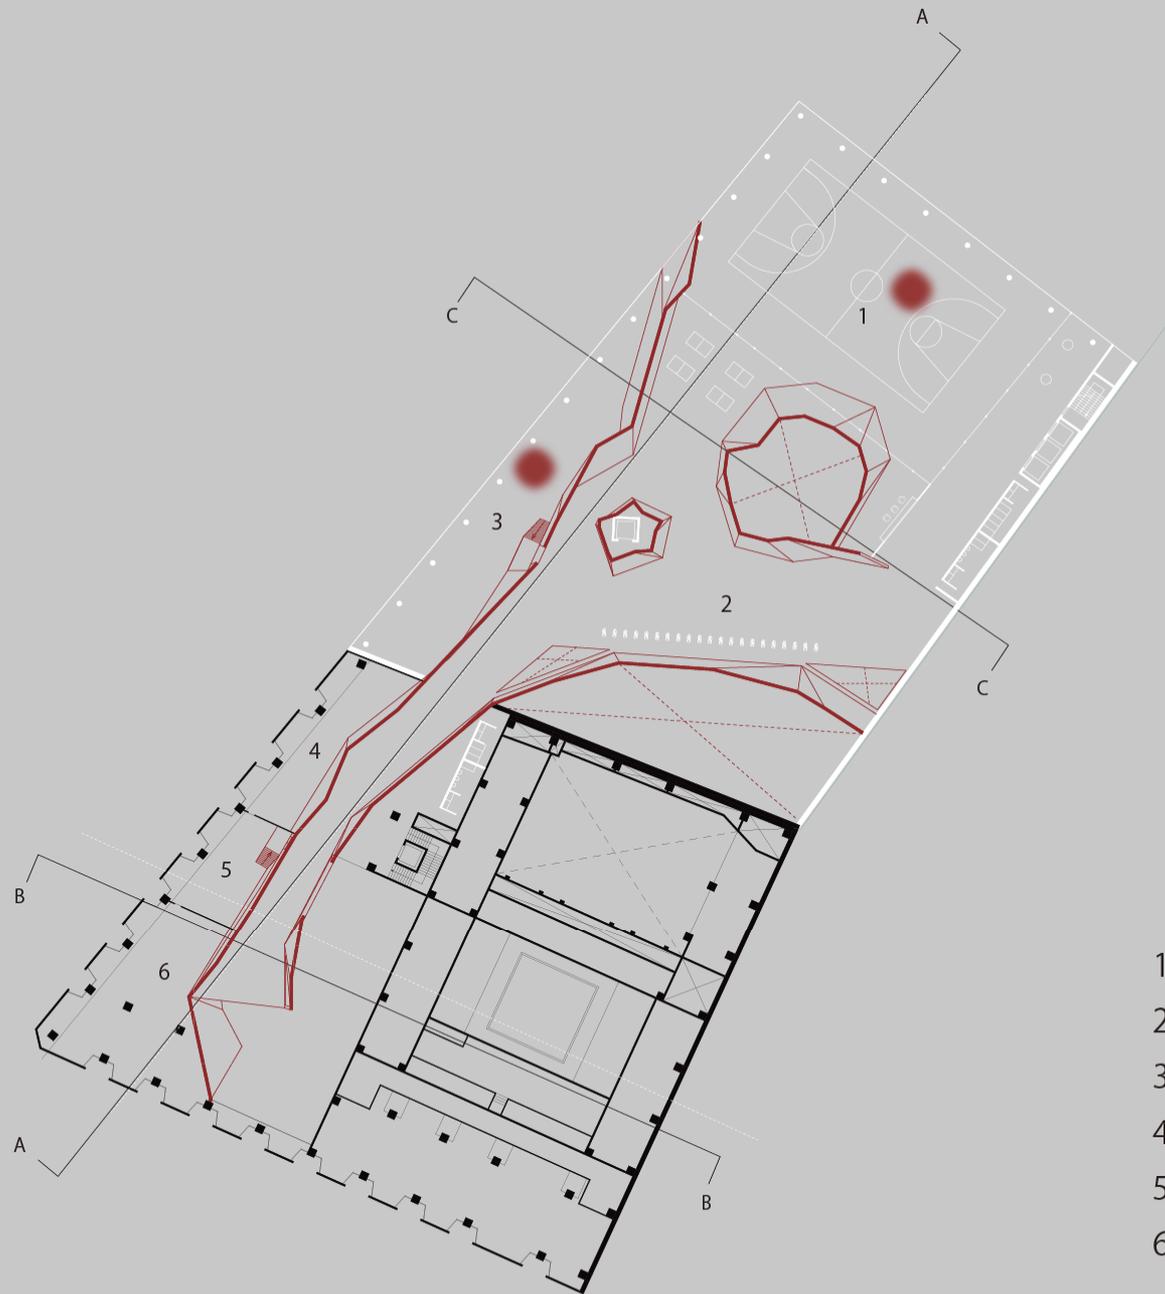
6th floor GL+24500 S=1/800

1. gymnasium
2. fitness club
3. rock climbing
4. dressing room 1
5. break room
6. dressing room 2

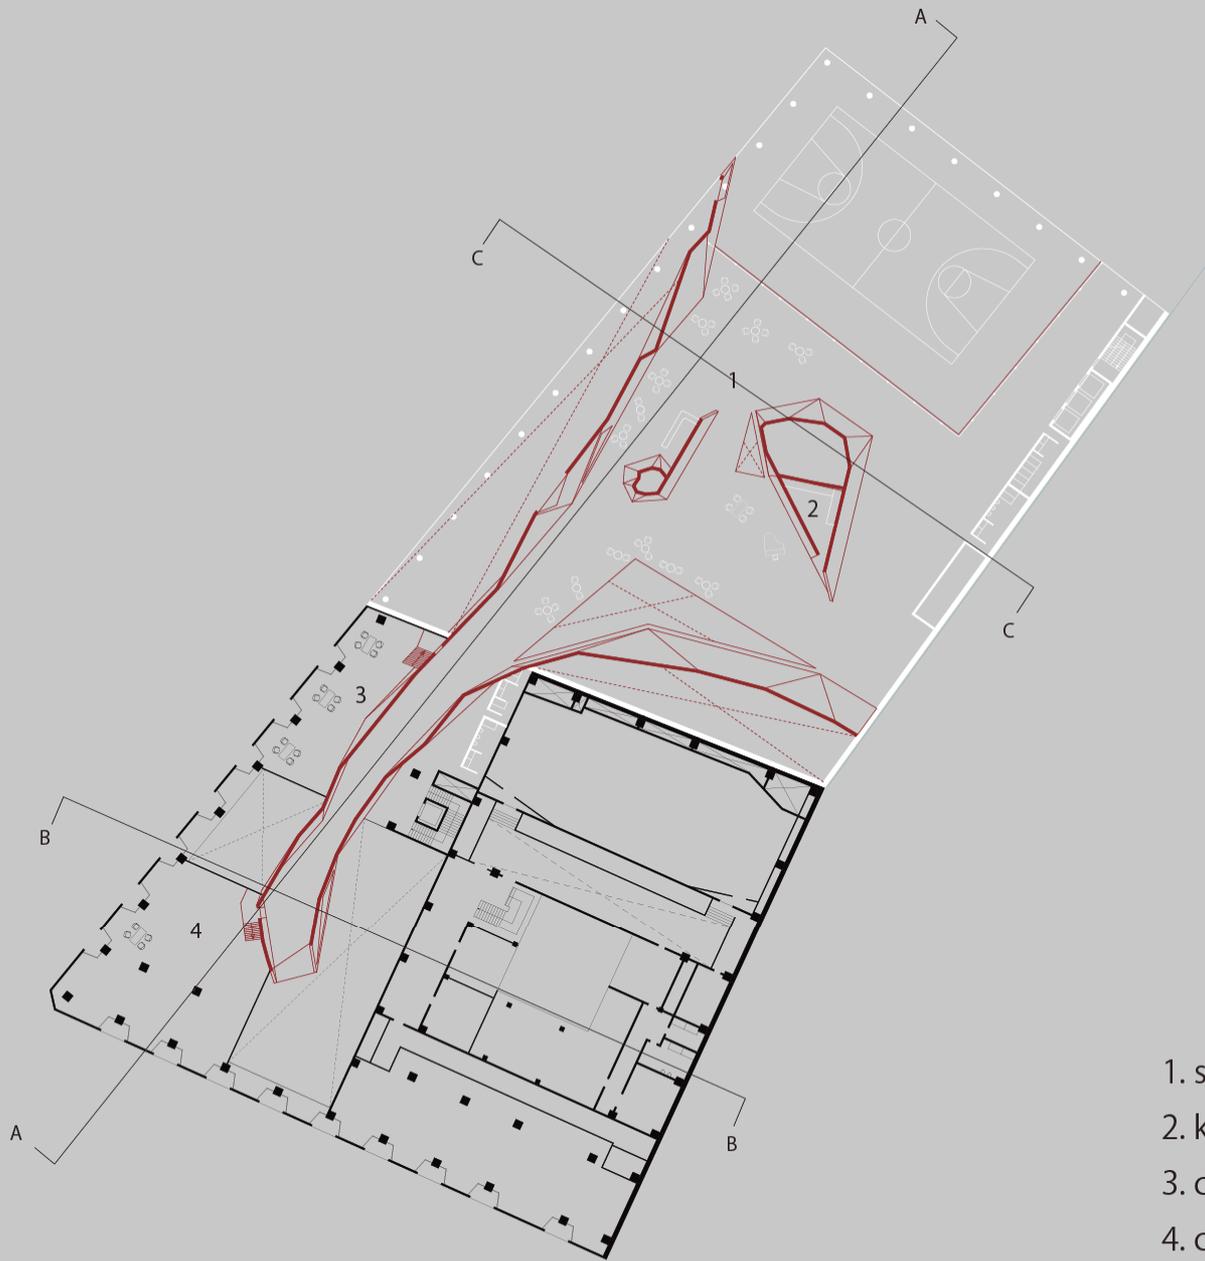
7th floor GL+28500 S=1/800

- 1. sports bar
- 2. kitchen
- 3. culture school 1
- 4. culture school 2
